TAP 307- 12: Tacoma Narrows: re - evaluating the evidence:

This reading is adapted from 'The collapse of the Tacoma Narrows bridge, evaluation of competing theories of its demise and the effects of the disaster on succeeding bridge designs' by James Koughan of the Department of Mechanical Engineering, University of Texas at Austin.

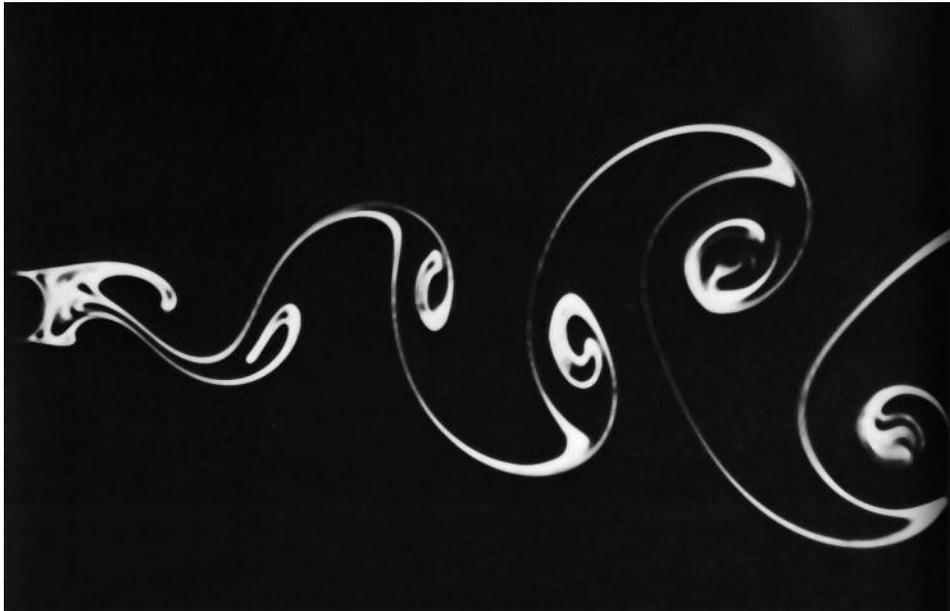
The long standing theory behind the collapse of the bridge was proposed by the leading aeronautical engineer Theodore von Kármán, who was on the committee set up to study the disaster. He was convinced that the oscillations were due to the shedding of vortices from the bridge. As air flows round an object, swirls of air, called vortices, are carried away by the wind. This is due to air at different speeds combining. Consider a car with the wheels on one side driving faster than the other. The result would be the car would turn with the faster wheels on the outside of the 'bend'. It is a common and recognised phenomena that with non-streamlined objects the vortices are shed from one side, then the other of the object (see below).

The vortices generate alternating high and low-pressure regions on the downwind side of the body, in this case the bridge. Such vortices are called Strouhal vortices and are shed at a rate determined by the equation

$$f_s = SU / D$$

where f_s is the frequency of vortex shedding, S is the Strouhal number (a constant for a given body shape), U is the velocity of the air flow and D is a characteristic dimension of the body (usually the width).

The characteristic dimension of the bridge was the thickness of the deck, which was 2.44 m. On the day of the collapse the wind speed was 68 km h^{-1} which, with an appropriate Strouhal number (developed by wind tunnel testing of many shapes over many years) gives a shedding frequency of about 1 Hz. A secondary effect would also have developed whereby the motion of the bridge would in turn generate vortices which would therefore be shed in time with the oscillations. This phenomenon is called 'lock on'. This is the generally accepted view of how the bridge came to shake itself to pieces.
